# Carlisle Culvert Assessment Report

April 2025

Town of Carlisle  
66 Westford Street  
Carlisle, MA 01741

Nitsch Engineering  
2 Center Plaza, Suite 430  
Boston, MA 02108

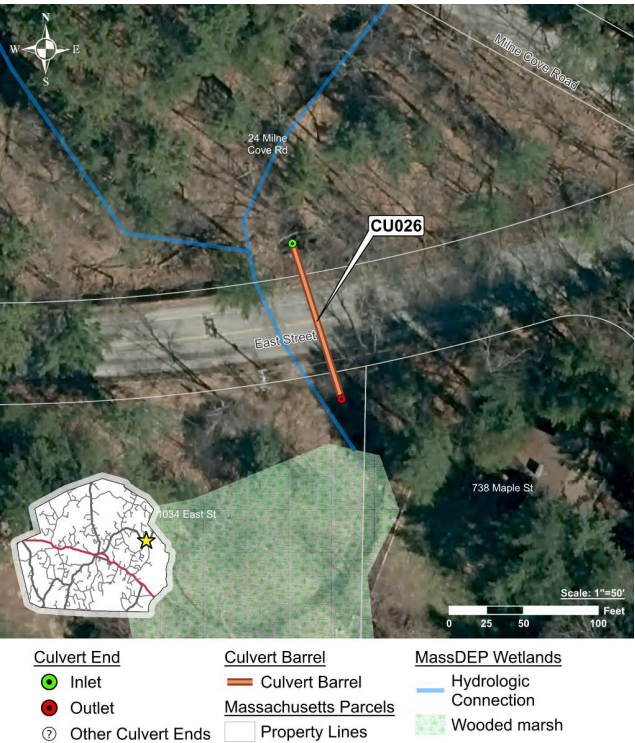
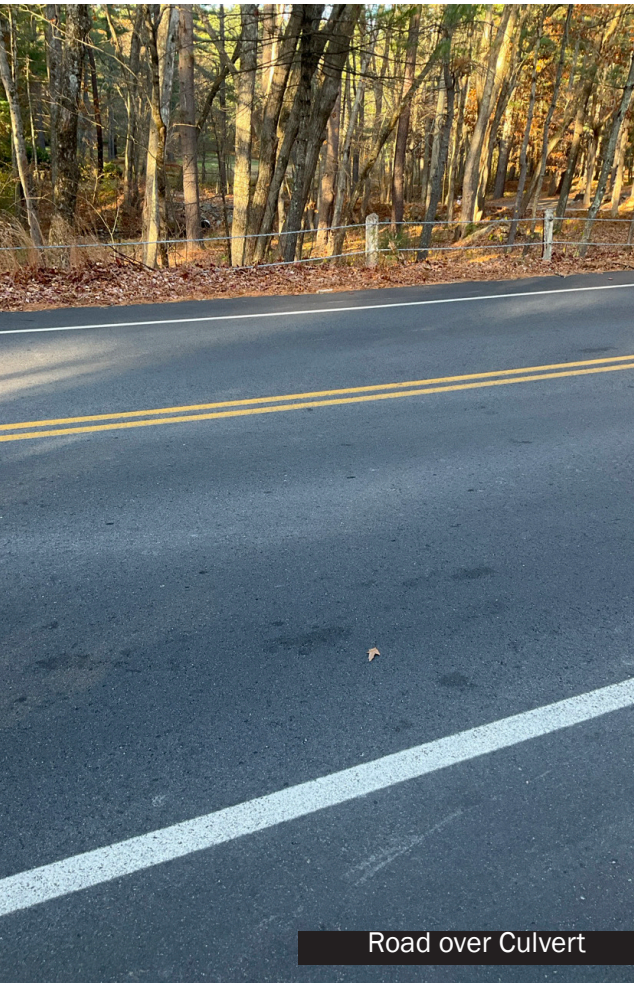
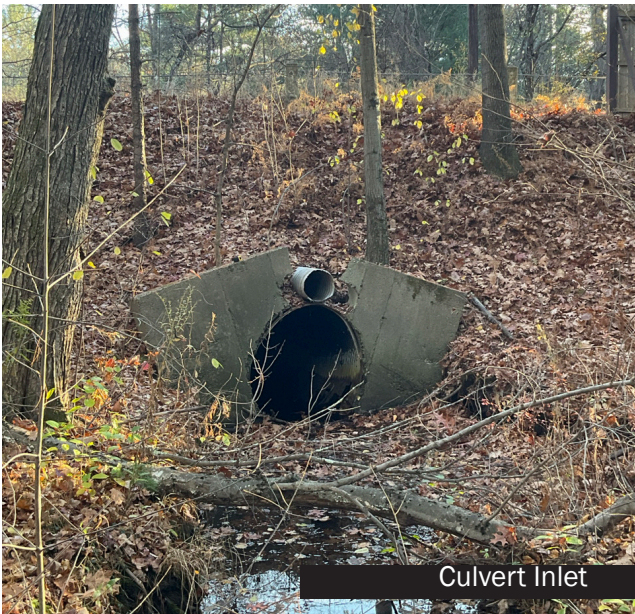
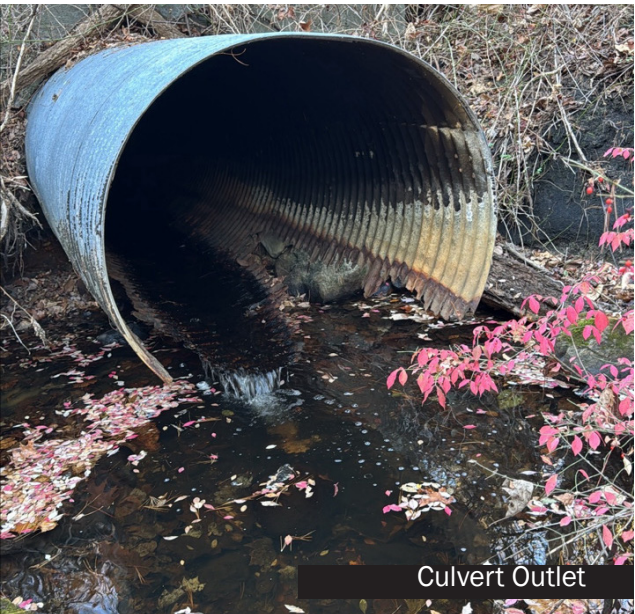
3.1 Culvert CU026

Culvert CU026 carries waterflow under East Street, a Minor Collector, through a 42-inch corrugated metal pipe. The water level was approximately 5% of the culvert capacity and was flowing at the time of assessment. The culvert received a Failing assessment of the inlet and a Poor assessment of the outlet, resulting in a high risk of failure. Culvert CU026 is considered a Critical Culvert based on its high risk of failure and moderate traffic disruption if the structure were to fail.

Inlet: The inlet embankment condition was Poor with moderate erosion near the base of the headwall and trees growing in close proximity. The concrete headwall was split down the center of the wall above the pipe. Both pieces of the headwall had rotated around the pipe away from each other. The headwall was given a Failing rating. The pipe at the inlet was in Poor condition with rust and section loss at the bottom of the pipe.

Outlet: The outlet embankment condition was Poor with heavy vegetation overgrowth around the headwall and sediment spilling over the top of the wall. The concrete headwall was observed to be in Poor condition. The pipe at the outlet extended approximately 10 ft past the headwall and was given a Failing rating due to major section loss and rust at the bottom of the pipe.

Potential repair options include a full replacement with excavation and removal of the existing culvert, and regrading and scour protection at the outlet of culvert. This option would need structural, hydraulic, and geotechnical engineering design to support the replacement.

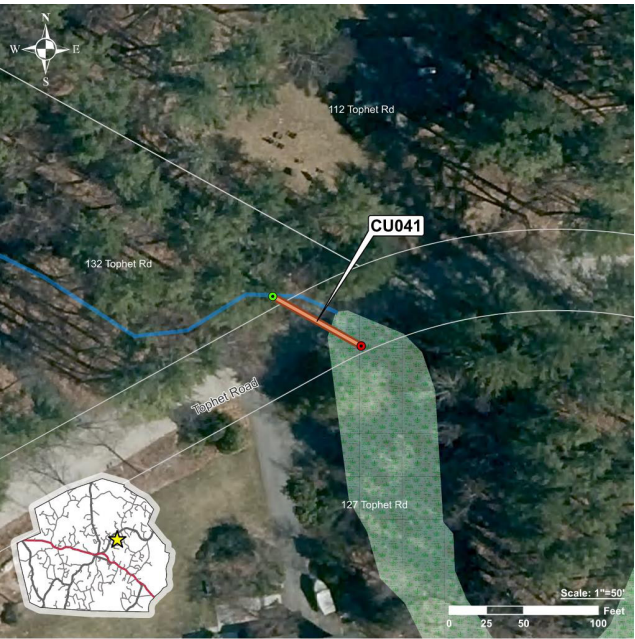
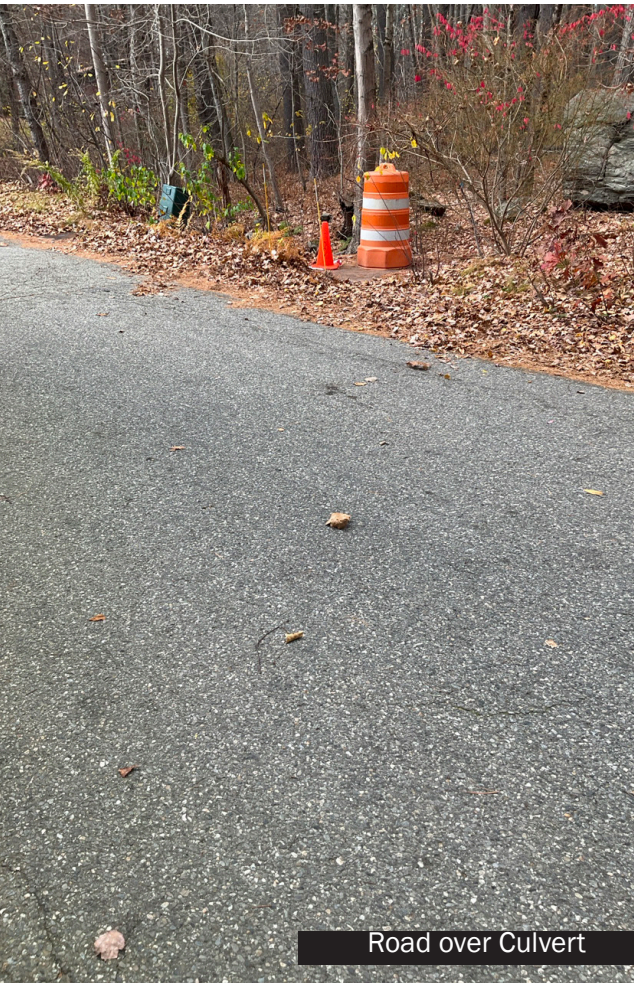
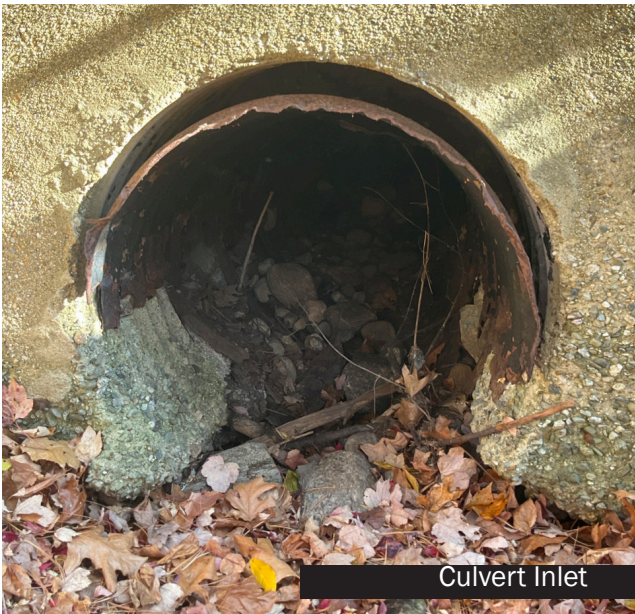
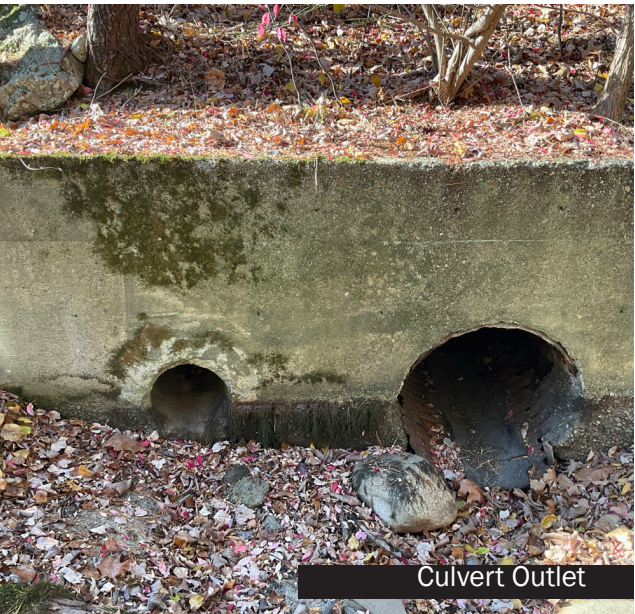
Culvert CU041 carries waterflow from a season stream under Tophet Road, a Local Road, through a 30-inch corrugated metal pipe. The culvert received a Failing assessment of the inlet and a Poor assessment of the outlet, resulting in a high risk of failure. Culvert CU041 is considered a Critical Culvert based on it's high risk of failure.

Inlet: The inlet embankments were poorly vegetated and Failing due to severe erosion on both sides of the headwall. The precast concrete headwall had moderate scaling and spalling at the bottom of wall and was in Poor condition. The corrugated metal pipe had severe rust and sections loss of the bottom 50% of the pipe approximately. The overall rating of the inlet was Failing.

Outlet: The outlet had rock embankments that were in Fair condition. The precast concrete headwall had moderate scaling and spalling at the bottom of wall and was in Poor condition. The corrugated metal pipe had severe rust and moderate section loss on the lower half of the pipe. The overall rating of the outlet was Poor.

Potential repair options include full culvert replacement, with re-grading and scour protection of the embankments.

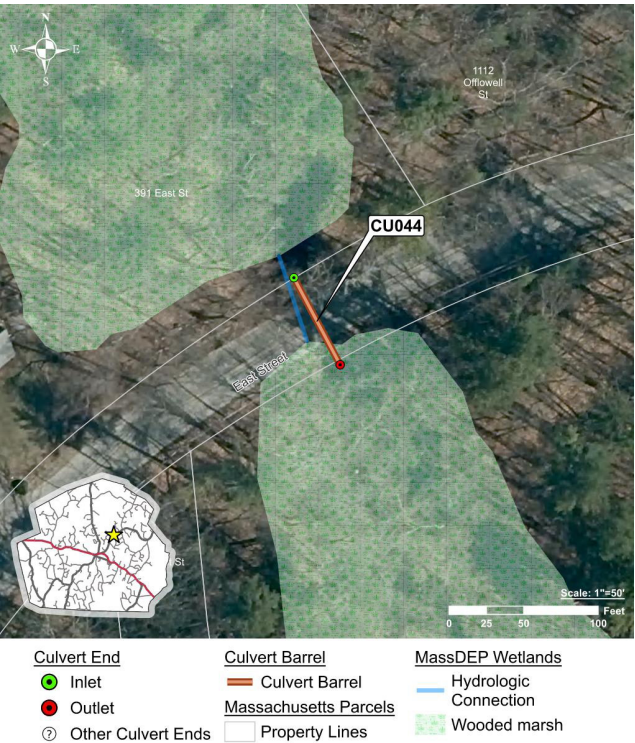
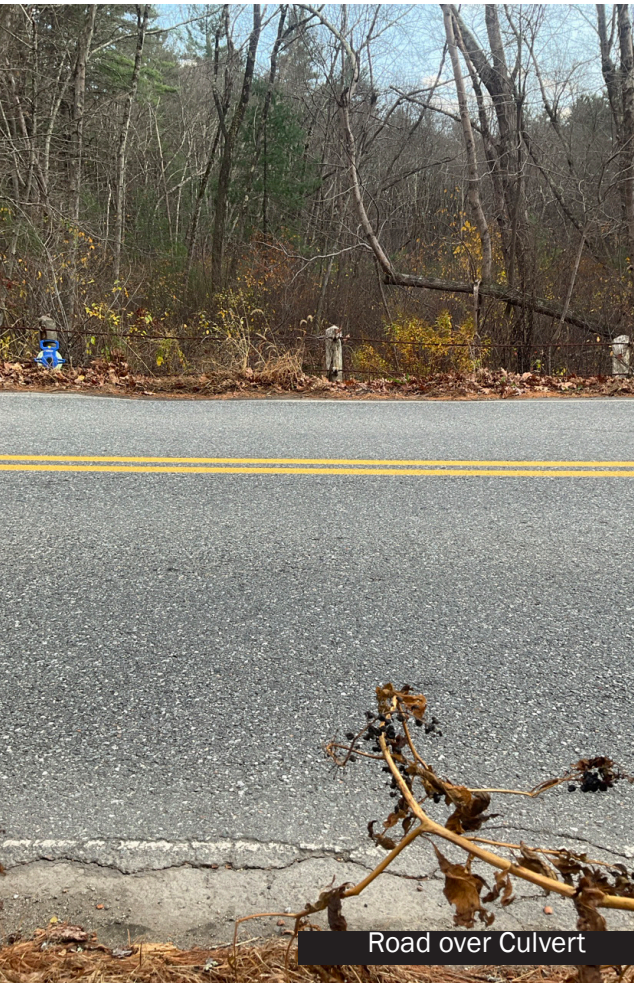
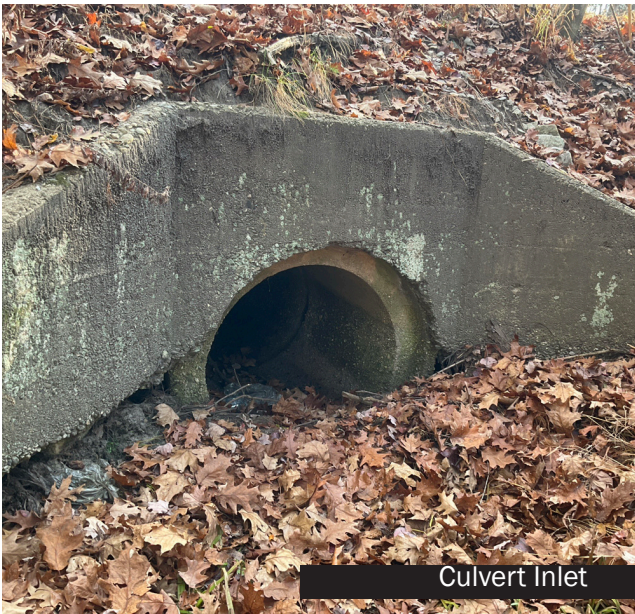
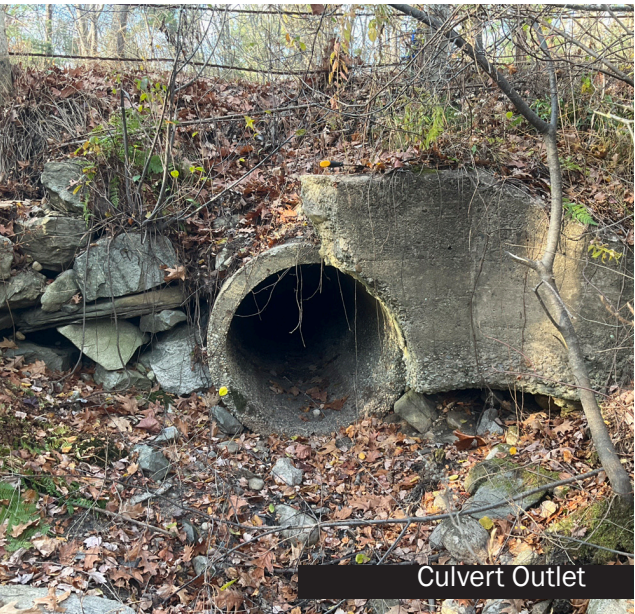
**Introduction**  
Culvert CU044 carries waterflow under East Street, a Minor Collector, through a 36-inch reinforced concrete pipe. The culvert received a Failing assessment of the inlet and a Poor assessment of the outlet, resulting in a high risk of failure. Culvert CU044 is considered a Critical Culvert based on its high risk of failure and significant traffic disruption if it were to fail.

Outlet: The embankment condition at the outlet was Poor with vegetation overgrowth and sediment spilling over the headwall. The headwall was in Failing condition as the entire left half of the headwall was missing. There was also scour present at the bottom of the intact section of the headwall. Similar to the inlet, the pipe was in Fair condition. The overall rating of the outlet was Failing.

**Recommendations**  
Potential repair options include full headwall replacements, with clearing overgrowth and revegetation of the embankments to stabilize the slope and minimize erosion.

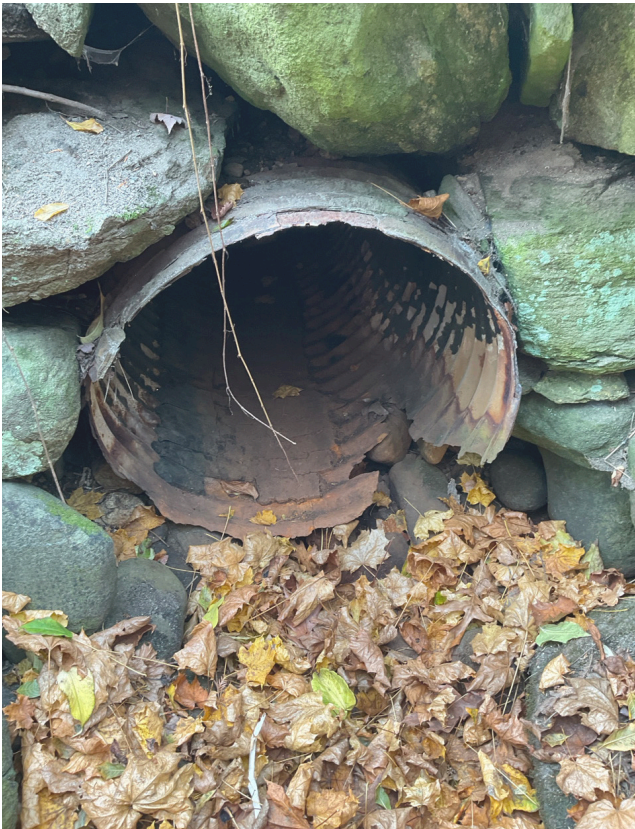
Fg 10. Culvert CU015 - Rust and Section Loss

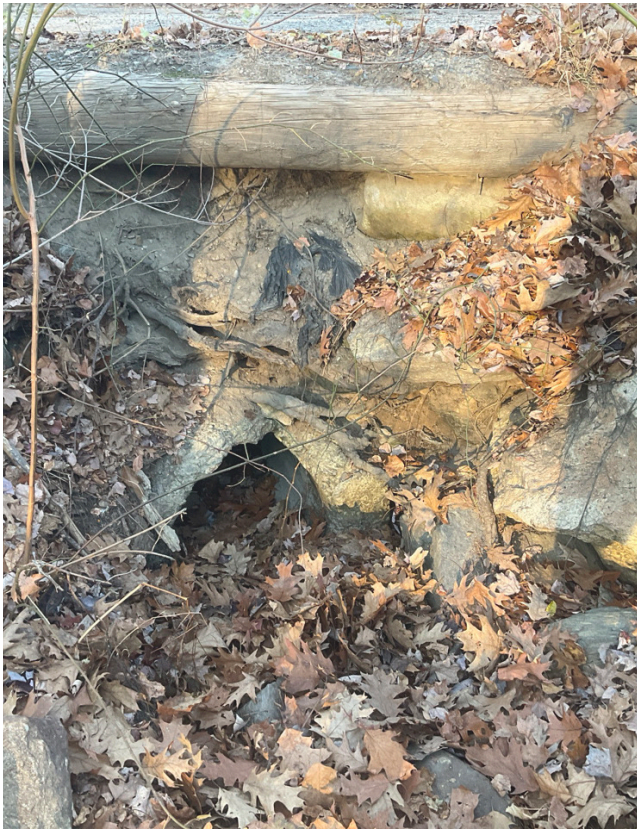
Fg 11. Culvert CU073 - Spalling Pipe

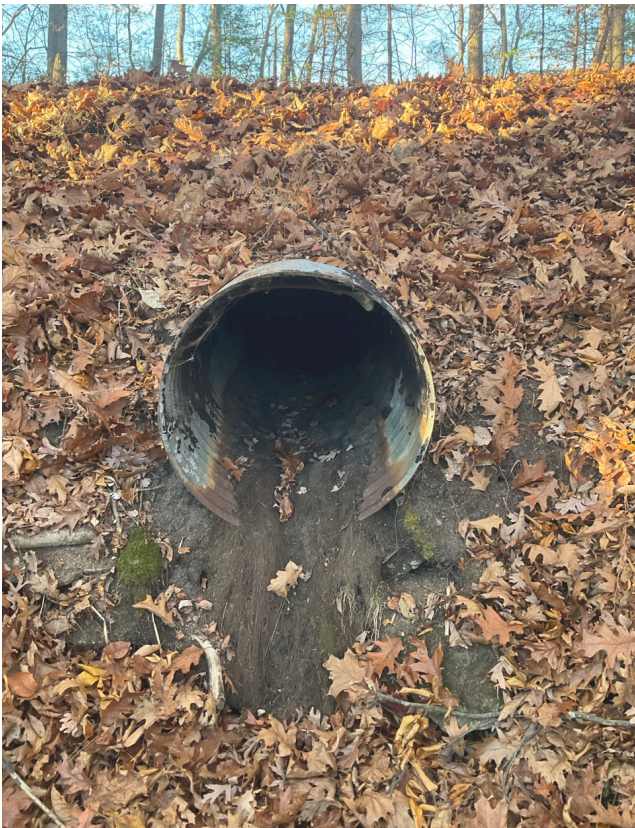
Fg 12. Culvert CU061 - Section Loss

| Culvert CU061 – North Rd | 32” round CMP in Poor condition due to rust and section loss at the bottom of the pipe. |

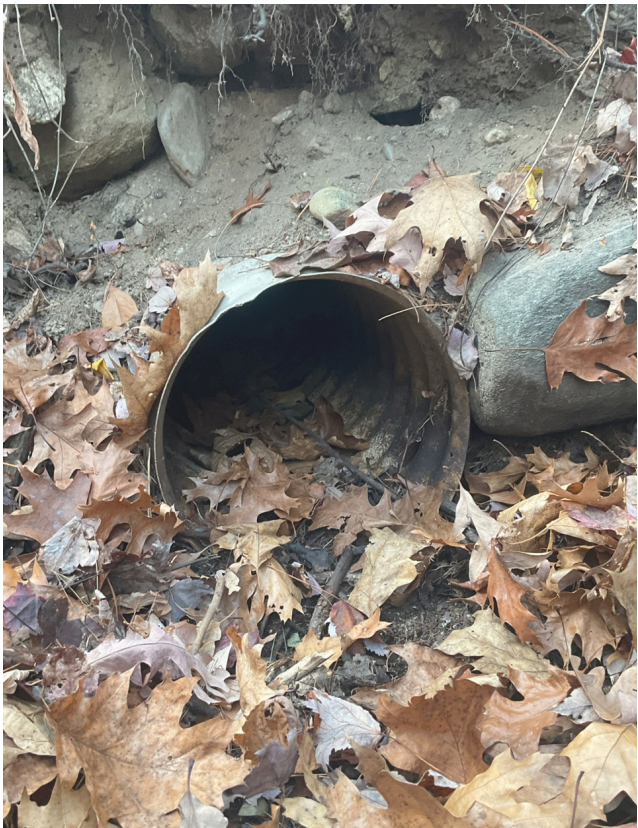
Fg 13. Culvert CU047 - Missing Headwall Stones
