Patch Meadow Lane / Rutland Street / North Road

Stats:
 22 parcels
 73.69 acres
 ~4.5 miles to North Billerica MBTA Station

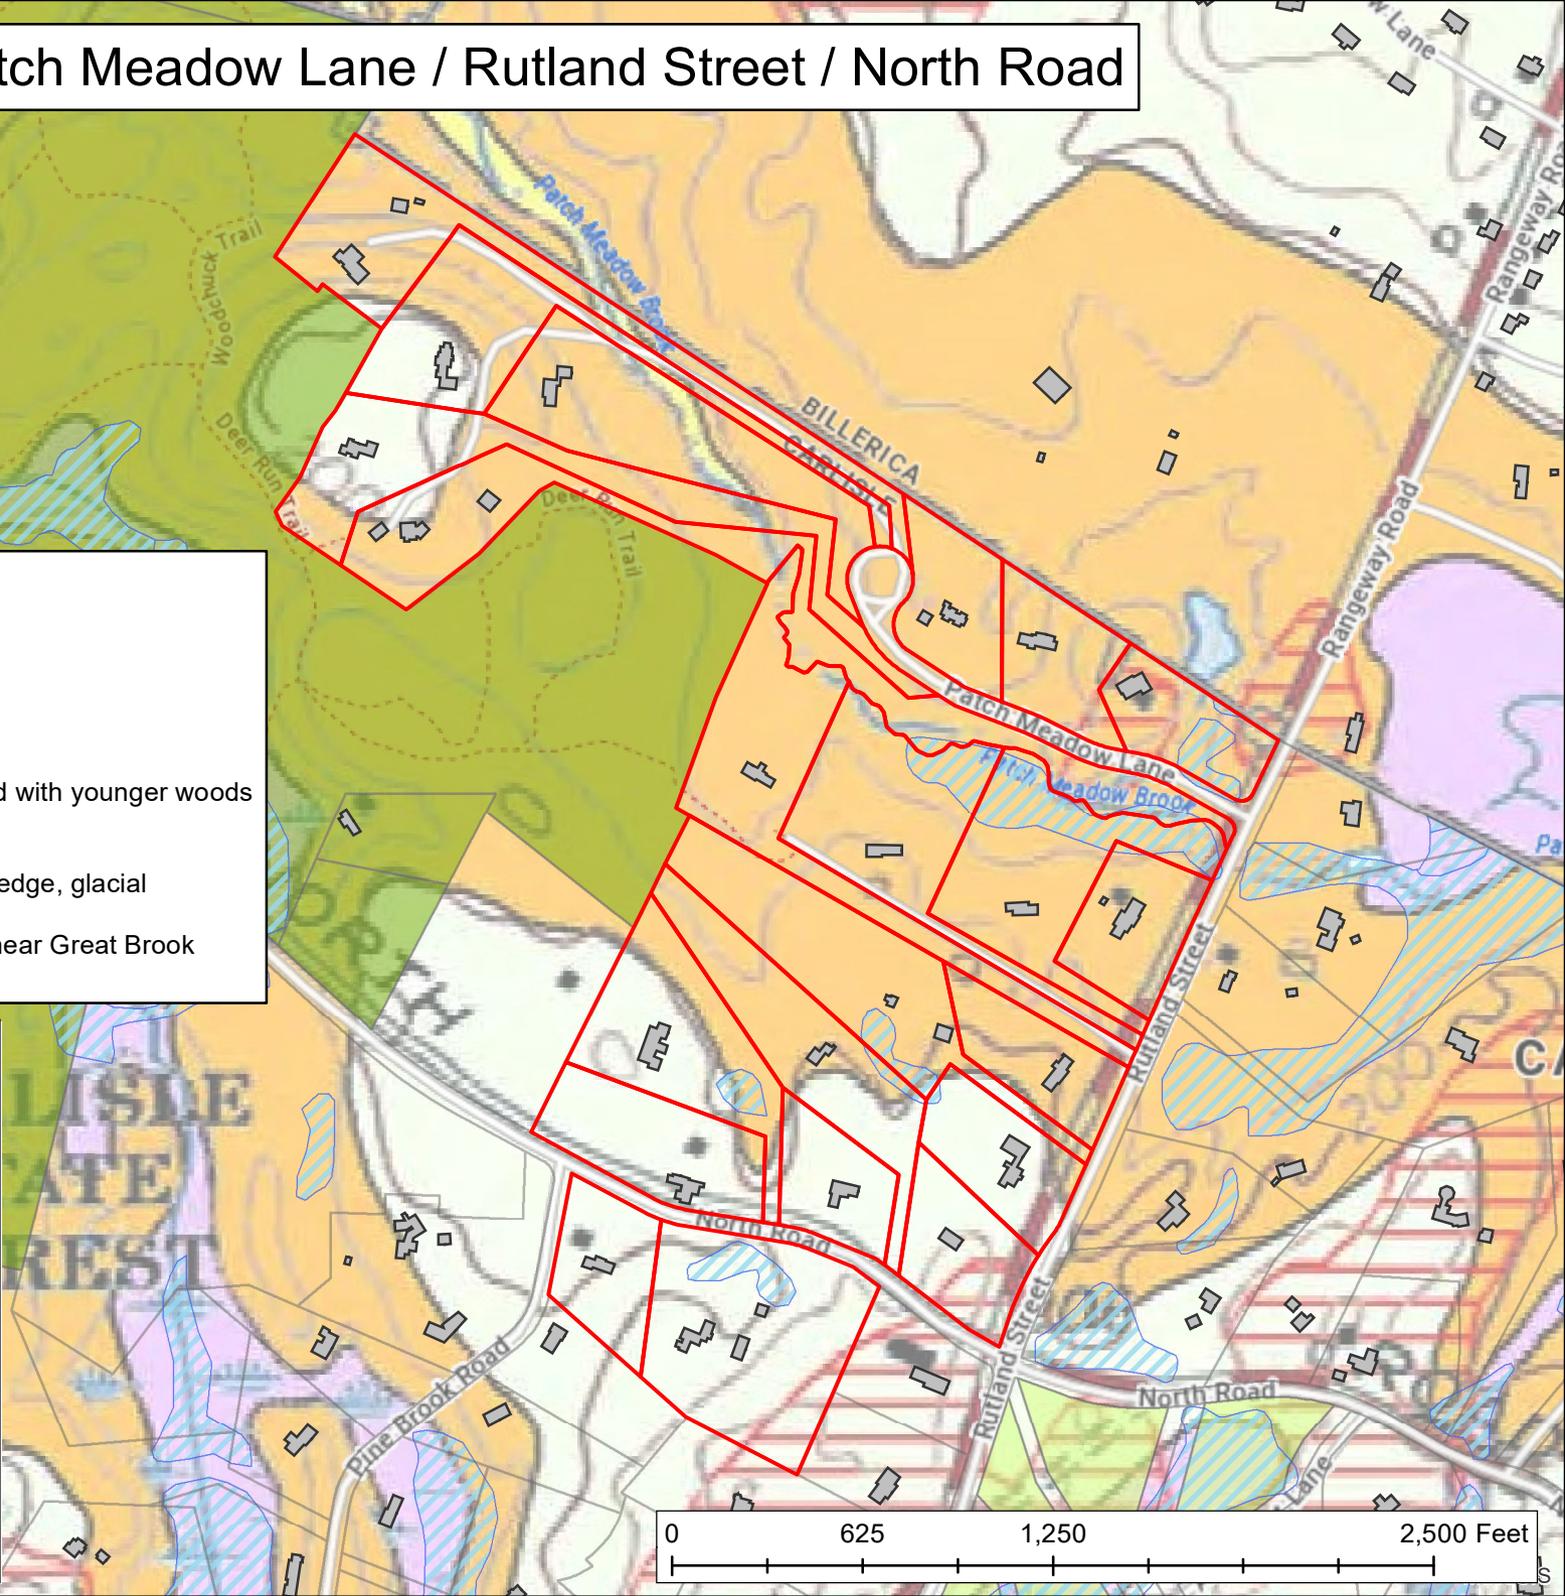
Why Here?
 -Access to collector road: Rte 4
 -Reduced disturbance: semi-disturbed land with younger woods
 -Older structures that may be redeveloped
 -Limited wetlands and wetlands buffers
 -Good geology & supportive soils: limited ledge, glacial stratified deposits
 -Balance of preservation & development: near Great Brook Farm State Park

Basemap: USGS Surficial Geology

- Orange/Blue = Glacial Stratified Deposits (good)
- Off-White/Green = Glacial Till Deposits (not good)
- Red Stripes = Bedrock Outcrops / Ledge (not good)
- Brown/Lime/Purple/Pink = Postglacial Deposits (not good)
