# Carlisle Culvert Assessment Report

April 2025

Town of Carlisle  
66 Westford Street  
Carlisle, MA 01741

Nitsch Engineering  
2 Center Plaza, Suite 430  
Boston, MA 02108

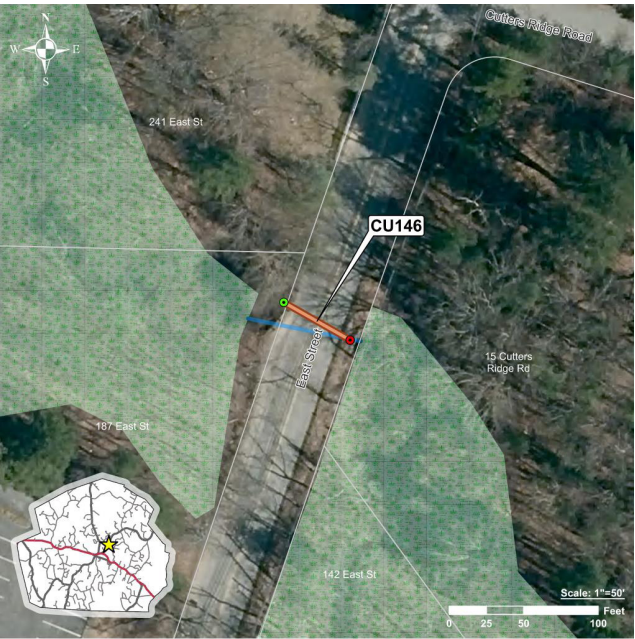
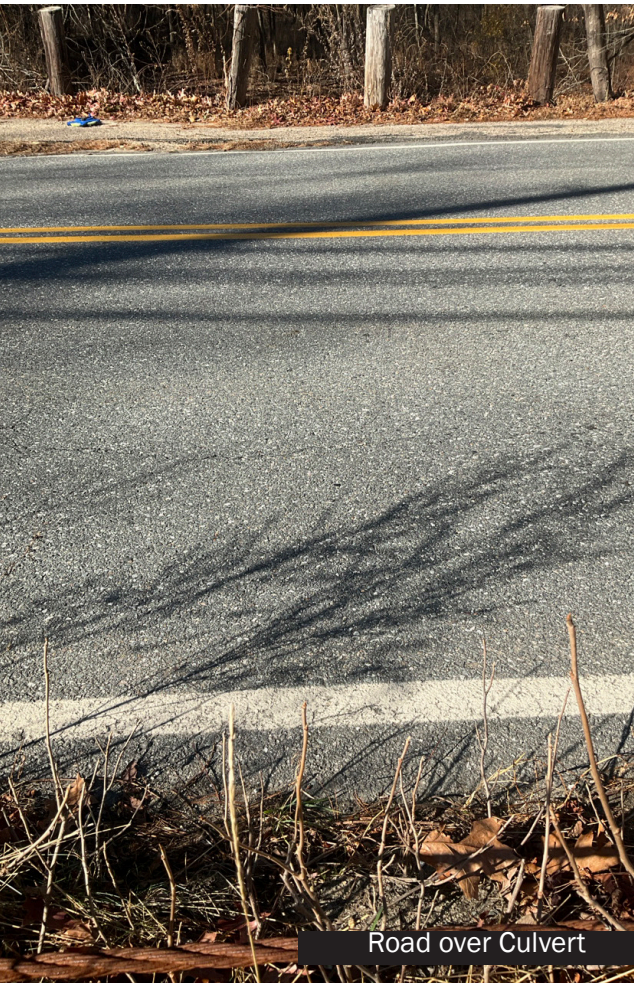
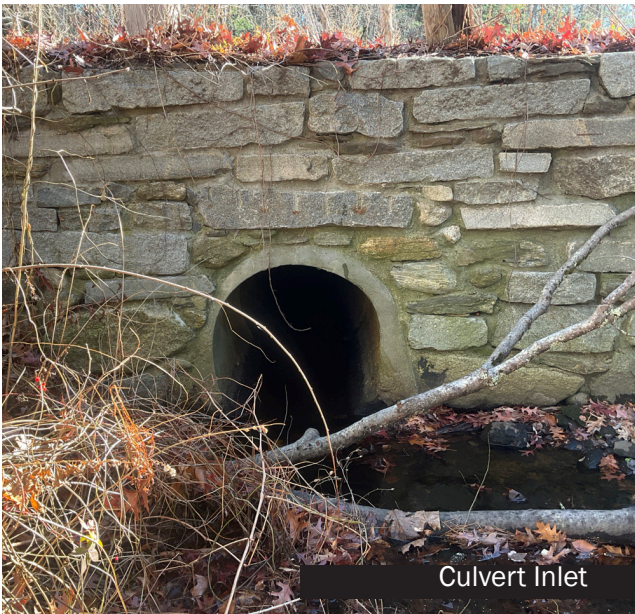
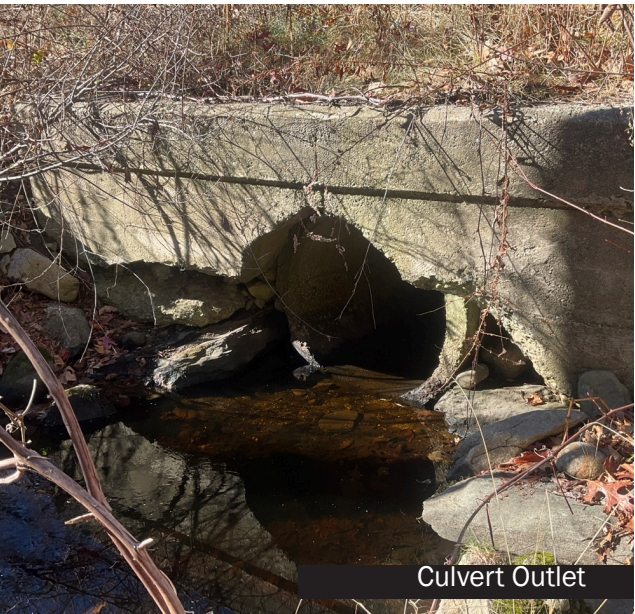
Culvert CU146 carries waterflow under East Street, a Minor Collector, through a 36-inch reinforced concrete pipe. The water level of the pipe was approximately 5% of the culvert capacity with stagnant flow at the time of assessment. The culvert received a Satisfactory assessment of the inlet and a Failing assessment of the outlet, resulting in a high risk of failure. Culvert CU146 is considered a Critical Culvert based on its high risk of failure and moderate traffic disruption if the structure were to fail.

Potential repair options include concrete headwall replacement at the outlet and clearing vegetation overgrowth and revegetation of the embankments to stabilize the slope and minimize erosion.

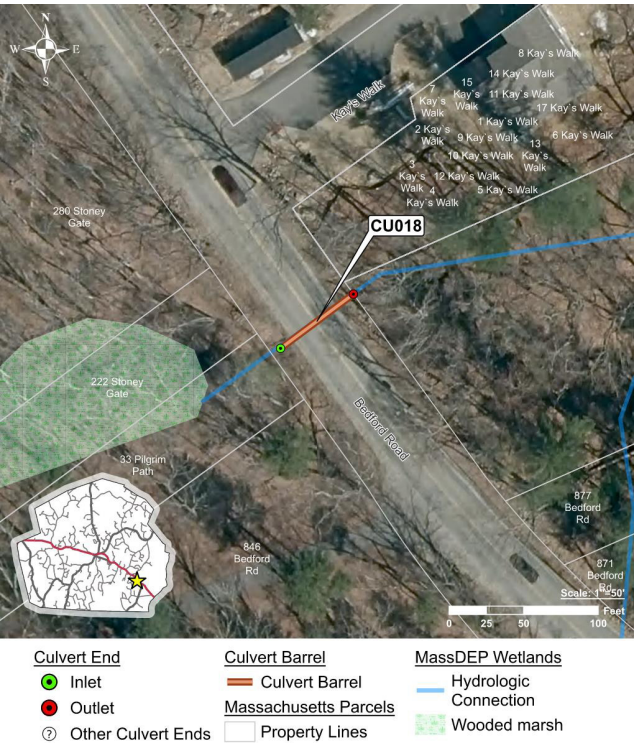
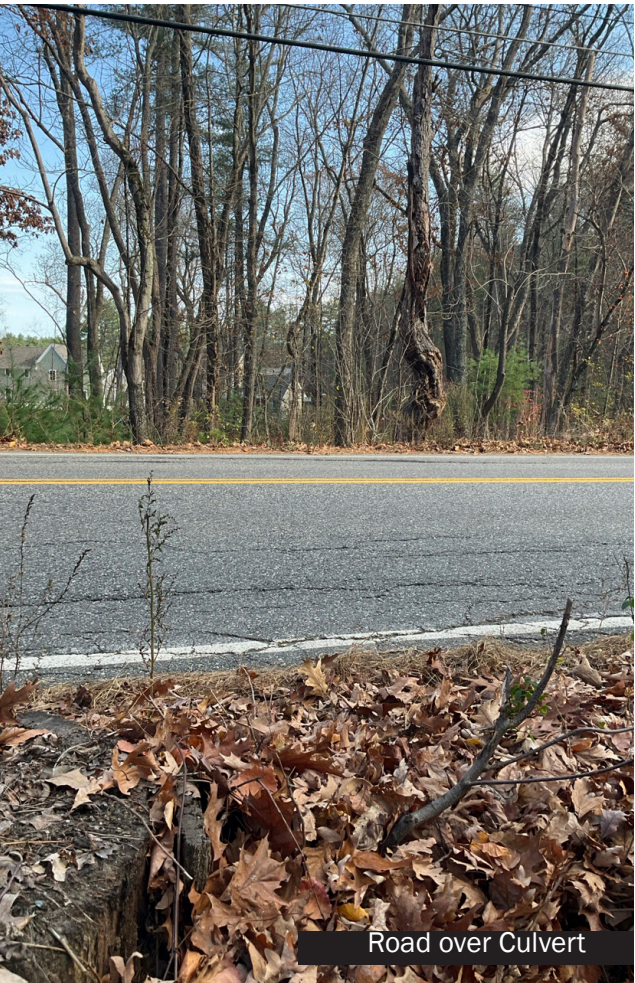
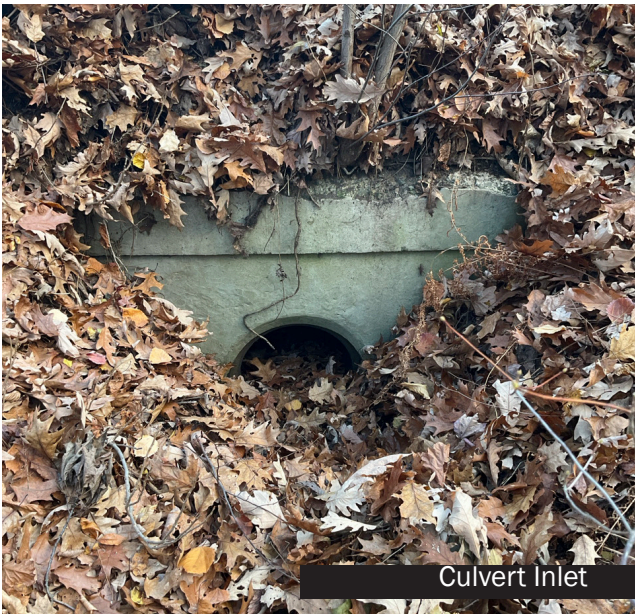
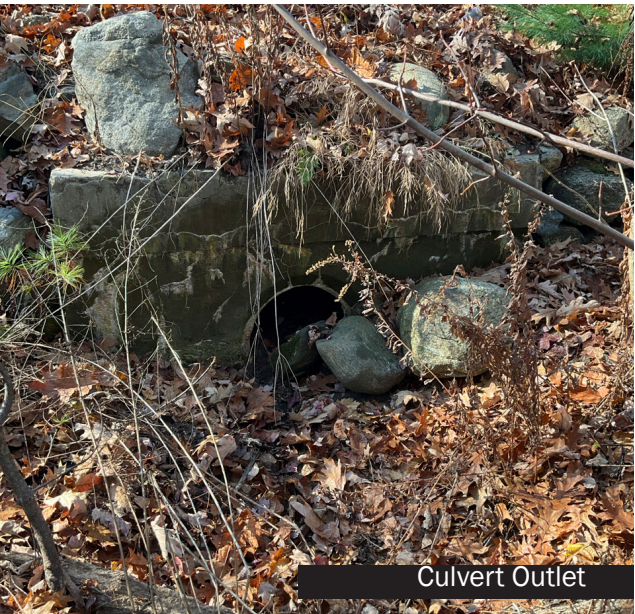
Outlet: The embankment condition at the outlet was Poor with moderate to heavy vegetation overgrowth and sediment spilling over the headwall. The headwall was in Failing condition with signs of rotation, spalling along the bottom of wall, cracking along the front face of wall, and moderate moss growth. The pipe received a satisfactory rating, but was around 90% obstructed with leaves, sticks, and sediment. The overall rating of the outlet was Failing.

**Recommendations**  
Potential repair options include headwall replacement at the outlet, spall repair at the inlet headwall, clearing out overgrowth and re-vegetation to stabilize slope and minimize erosion, and cleaning out or jetting of the pipe.

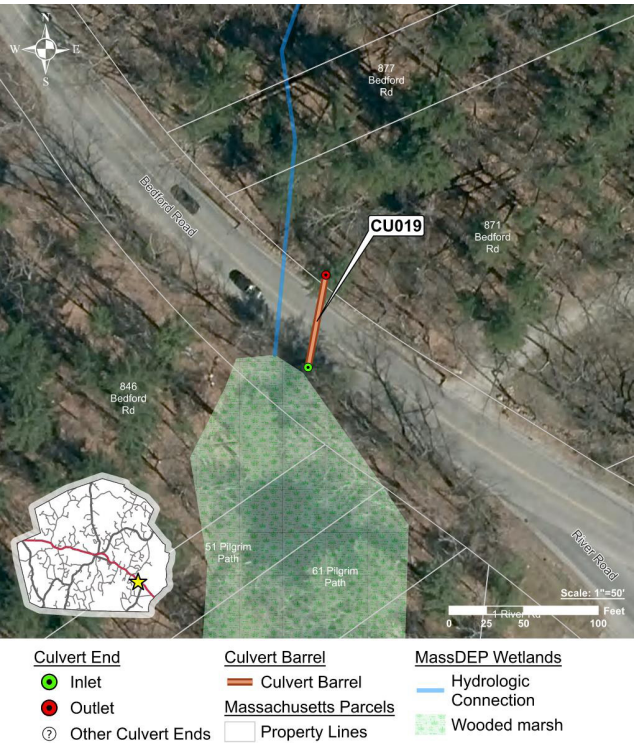
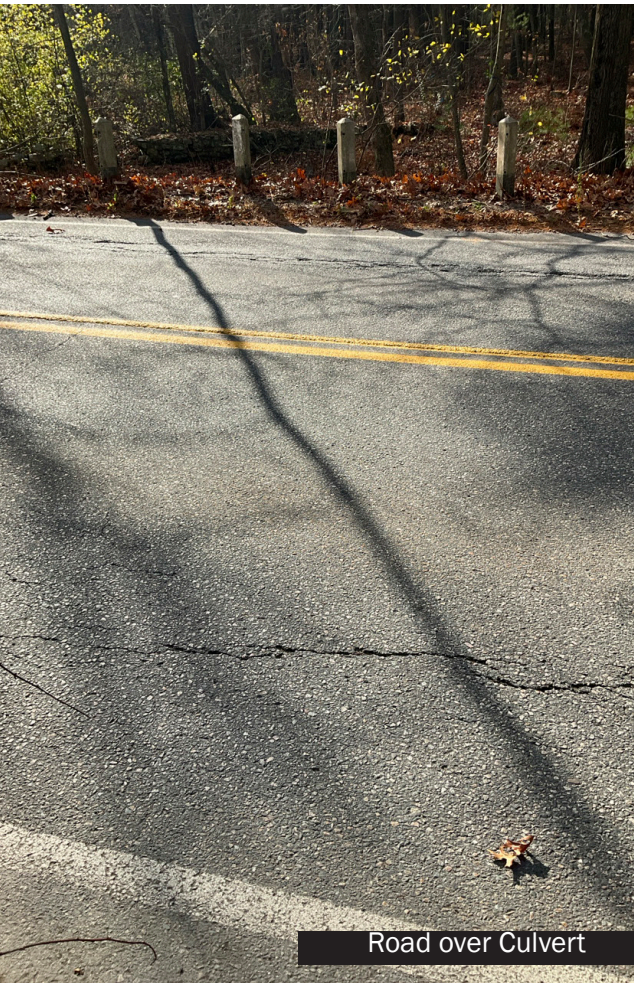
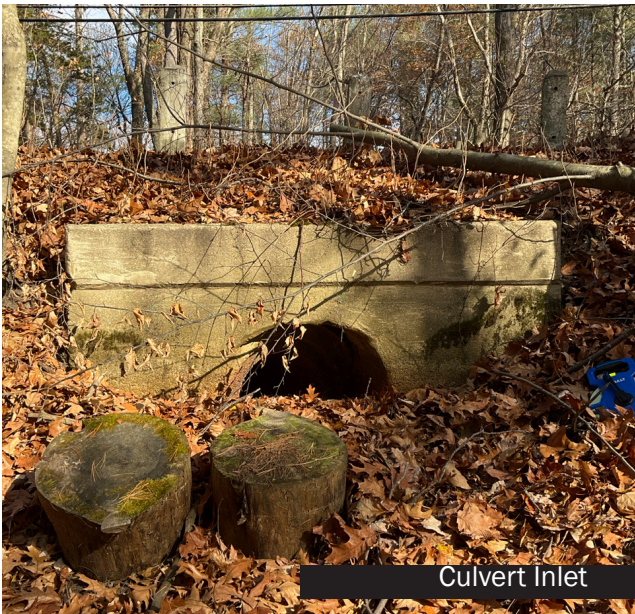
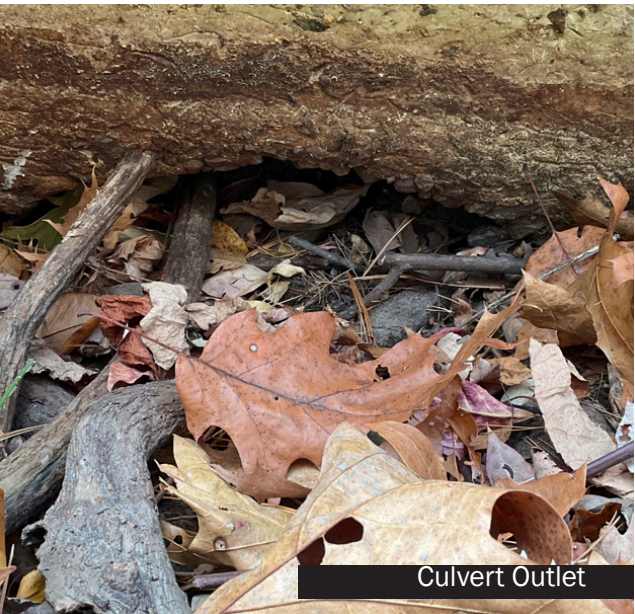
Outlet: The embankment condition at the outlet was Poor with moderate to heavy vegetation growth and sediment spilling over the headwall. The headwall was in Failing condition with signs of rotation, cracking along the front face of wall, spalling along the bottom of wall, and moderate moss growth. The pipe received a Fair rating due to moderate spalling within the pipe. The overall rating of the outlet was Failing.

**Recommendations**  
Potential repair options include headwall replacement at the outlet, spall and crack repair at the inlet headwall, and revegetation of the embankments to stabilize slope and minimize erosion.

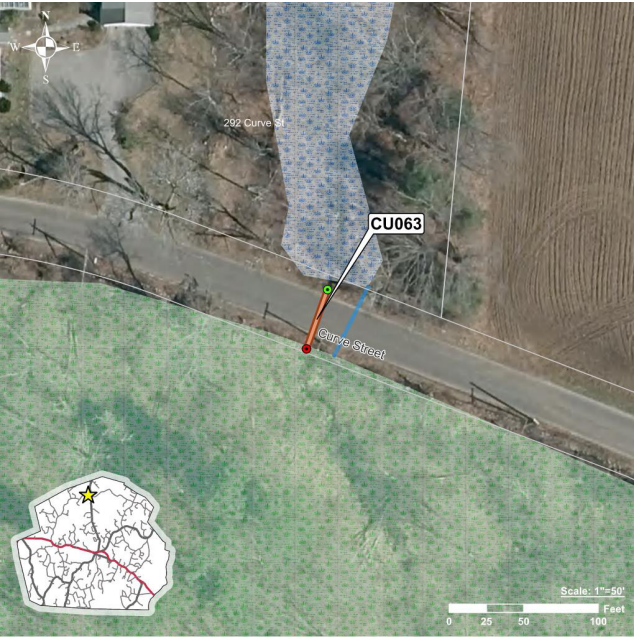
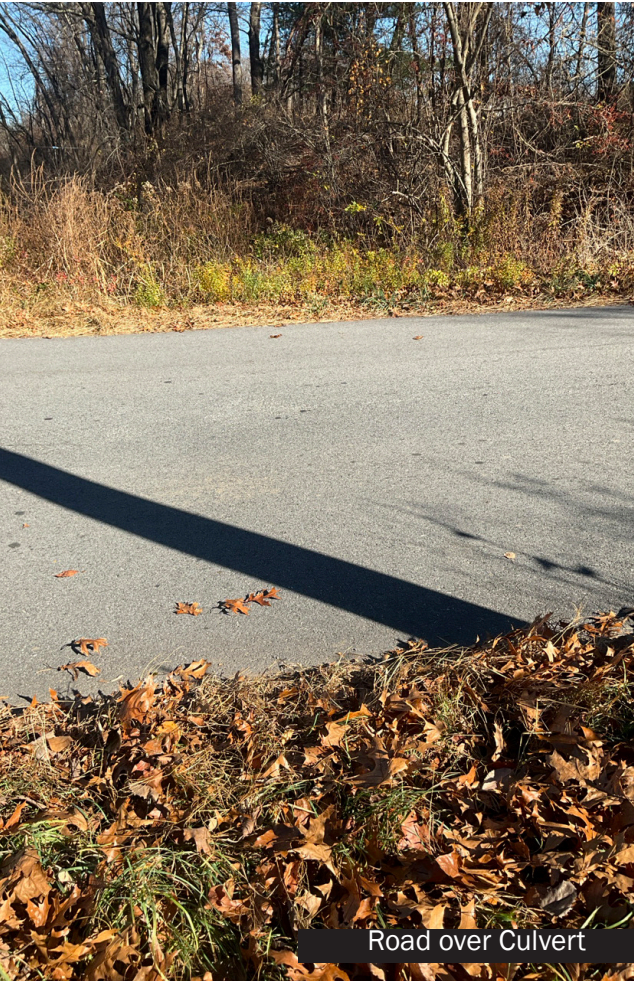
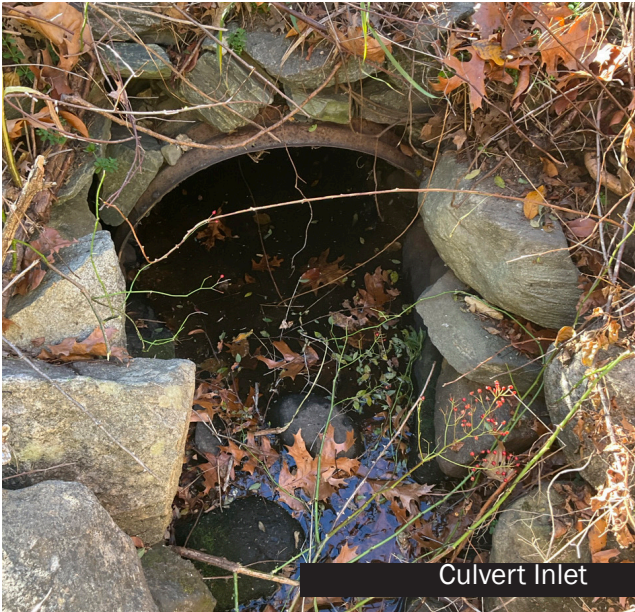
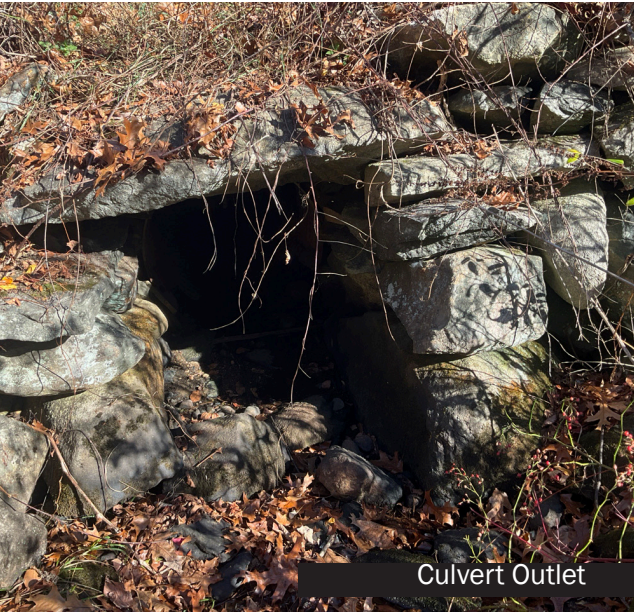
| Culvert Information | | | | | | | | | |
|---|---|---|---|---|---|---|---|---|--|
| 30 | 30 | 31 | Corrugated Metal Pipe | Round | None | Sediment at outlet , branches inside pipe, but most of pipe is unobstructed | Poor | Major section loss and rusting at both inlet and outlet | |

Potential repair options include spin cast lining inside the pipe if a hydraulic analysis shows the pipe is adequate in size. Otherwise, a full replacement would be needed.

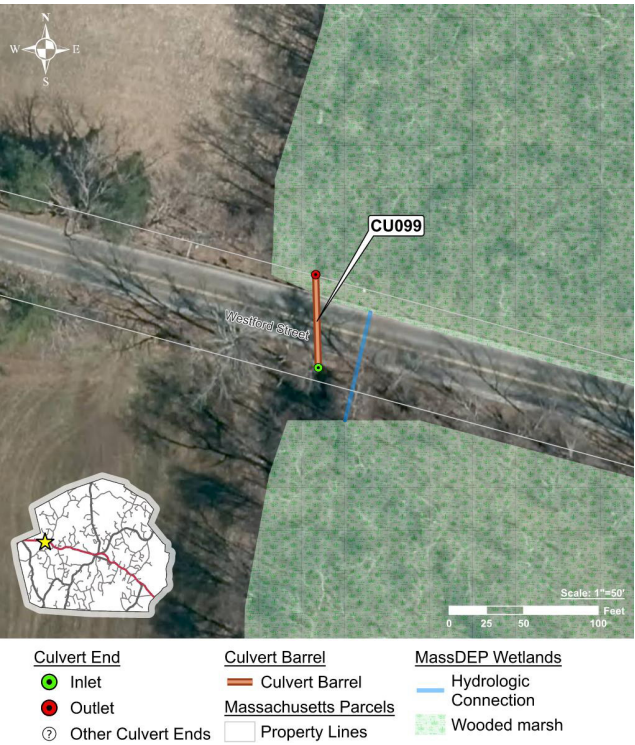
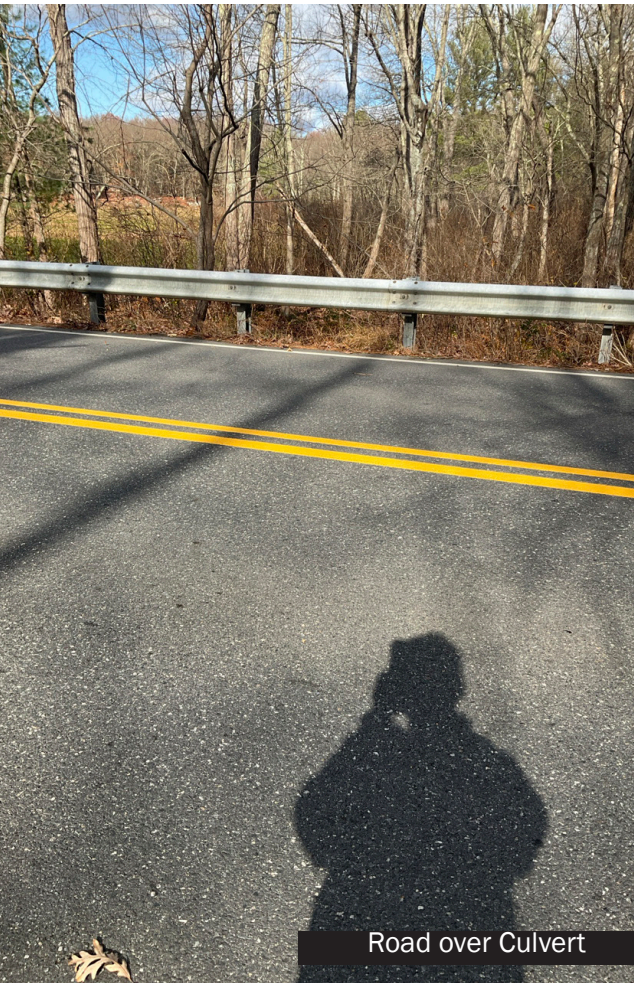
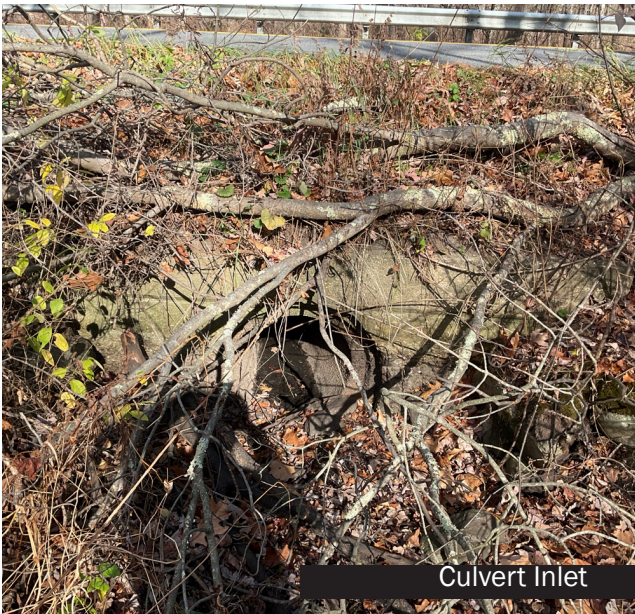
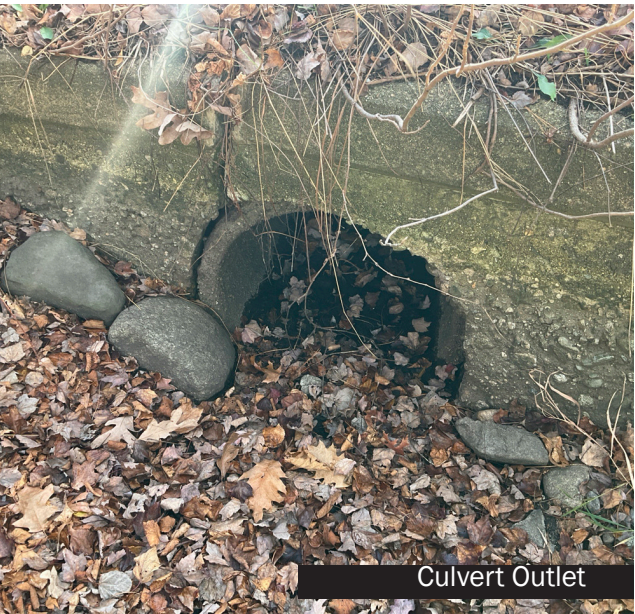
**Introduction**  
Culvert CU099 carries waterflow under Westford Street, A Major Collector, through a 24-inch reinforced concrete pipe. There was no water recorded at the time of the assessment. The culvert received a Poor assessment of the inlet and a Poor assessment of the outlet, resulting in a high risk of failure. Culvert CU099 is considered a Critical Culvert based on its high risk of failure and significant traffic disruption due to the traffic volume and long detour if the structure were to fail.

**Existing Conditions**  
Inlet: The embankment condition at the inlet was Poor with heavy vegetation overgrowth, erosion around the headwall, and sediment spilling over the top of wall. The headwall was in Poor condition, with spalling and moss growth along the face of the wall. The pipe at the inlet was in Fair condition due to moderate scaling inside the pipe. The overall rating of the inlet was Poor.

Outlet: The embankment condition at the outlet was Fair to Poor, with moderate vegetation overgrowth and sediment spilling over the headwall. The headwall was in Poor condition with a substantial crack down the center of the wall above the pipe and spalling along the face of the wall. The pipe at the outlet was in Fair condition due to moderate scaling inside the pipe. The overall rating of the outlet was Poor.

| Culvert Information | | | | | | | | | |
|---|---|---|---|---|---|---|---|---|--|
| 24 | 24 | 46 | Reinforced Concrete Pipe | Round | None | None | Fair | Pipe in fair condition, headwalls poor | |

| Headwall Information | | | | |
|---|---|---|---|---|
| Concrete | Poor | Concrete | Poor | Moss, cracks, erosion at base of headwall |

**Recommendations**  
Potential repair options include headwall replacements, clearing overgrowth and revegetation of the embankments to stabilize the slope and minimize erosion.

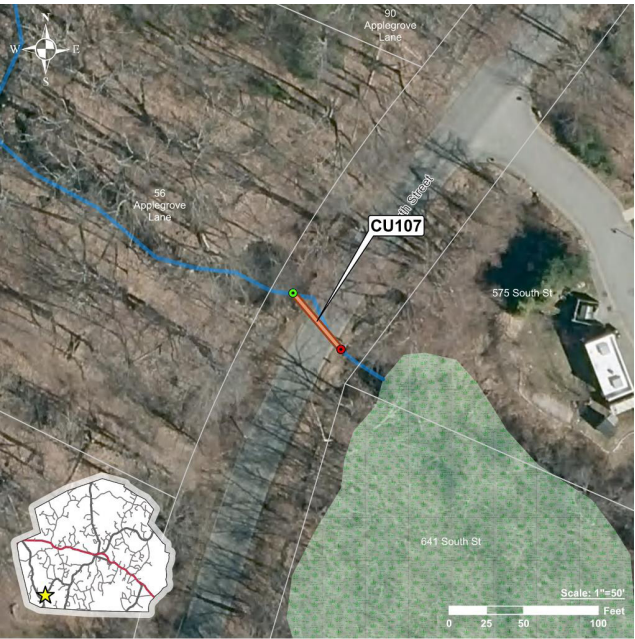
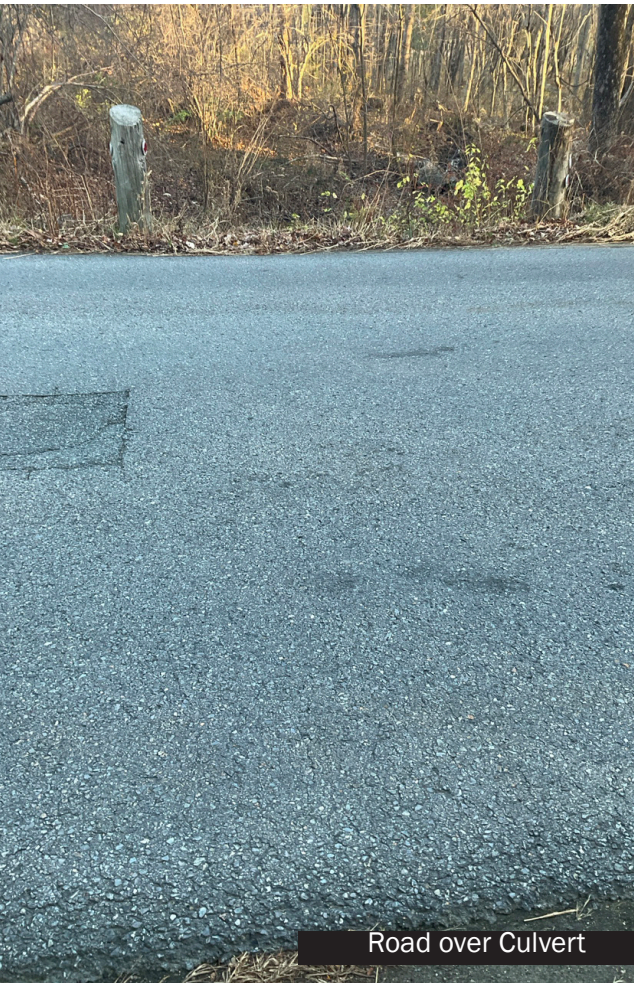
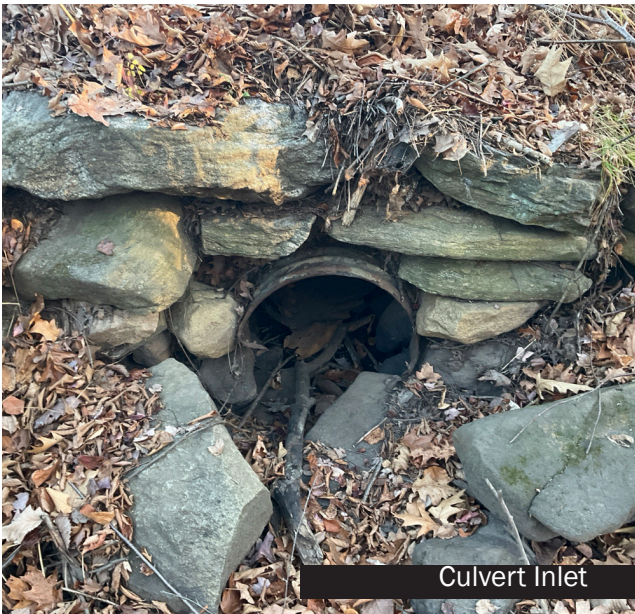
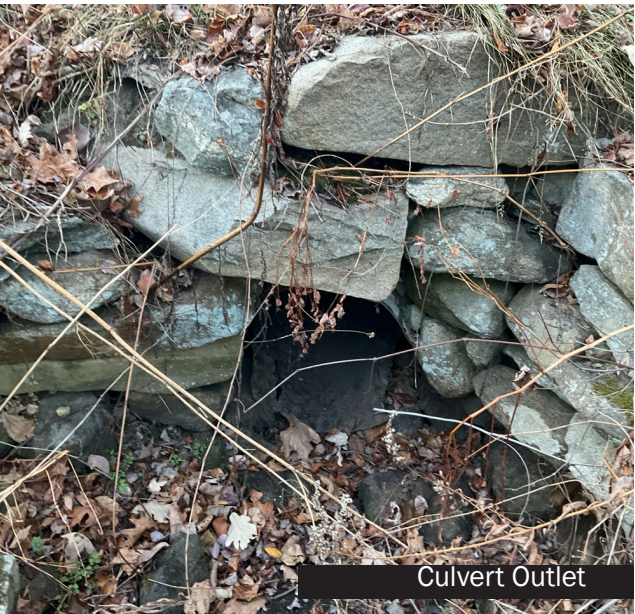
Culvert CU107 carries waterflow under South Street, a Minor Collector, through a 24-inch corrugated metal pipe. There was no water recorded at the time of the assessment. The culvert received a Fair assessment of the inlet and outlet headwalls and embankments but received a Poor assessment rating of the pipe itself, resulting in a high risk of failure. Culvert CU107 is considered a Critical Culvert based on its high risk of failure and moderate traffic disruption due to long detour if the structure were to fail.

Inlet: The embankments at the inlet were in Fair condition. The headwall was in Fair condition with minor missing stones that did not affect the integrity of the structure. The pipe at the inlet was in Poor to Failing condition, with severe section loss and rust.

Outlet: The embankments at the outlet were in Fair condition with vegetation overgrowth and sediment seeping through the headwall. The headwall was in Fair condition with minor missing or collapsing stones that did not affect the integrity of the structure. The pipe at the outlet was in Poor to Failing condition, with severe section loss and rust from the edge of the outlet to approximately 3 ft within the pipe. Beyond that, rust was observed with no visible section loss within the pipe.

| Culvert Information | | | | | | | | | |
|---|---|---|---|---|---|---|---|---|--|
| 24 | 24 | 37 | Corrugated Metal Pipe | Round | None | None | Poor | Headwalls fair. Major section loss and rusting at inlet/ outlet to ~3 ft in. Inside of pipe has rust but no visible section loss | |

Potential repair options include resetting the stone headwalls and spin cast lining inside the pipe if a hydraulic analysis shows the pipe is adequate in size. Otherwise, a full replacement would be needed.

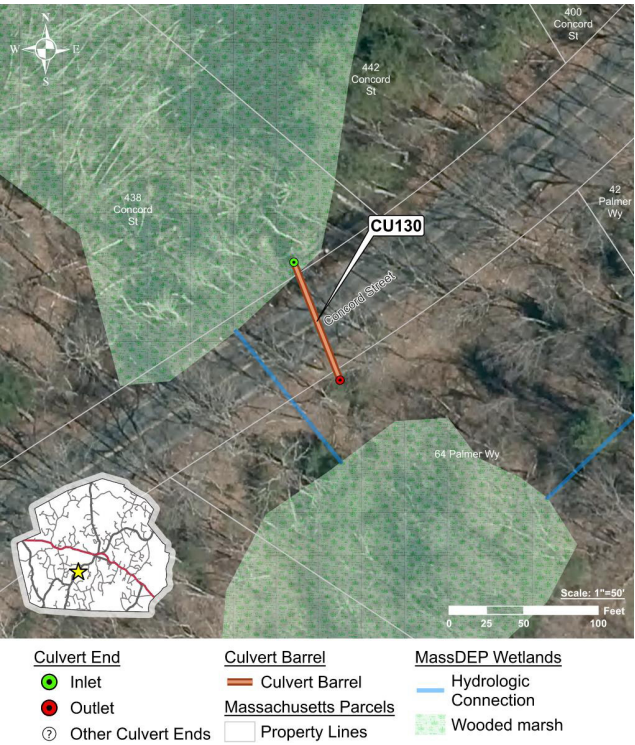
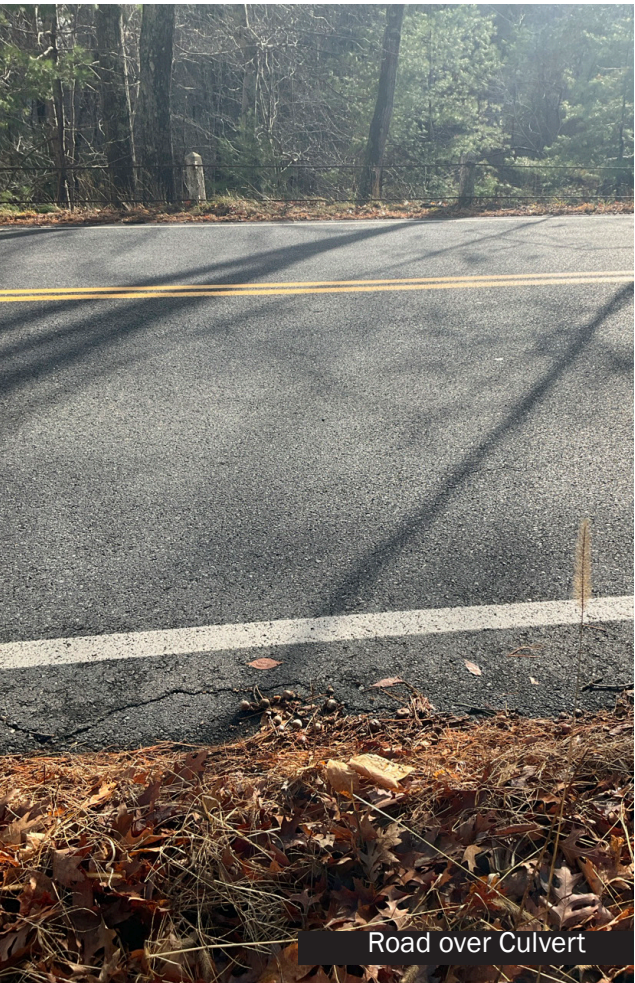
Road over Culvert

**Introduction**  
Culvert CU130 carries overflow from a wetland area under Concord Street, a Major Collector, through an 18-inch reinforced concrete pipe. The culvert received a Failing assessment of the inlet, and a Fair assessment of the outlet, resulting in a high risk of failure. Culvert CU130 is considered a Critical Culvert due to the risk of failure and significant traffic disruptions if the structure were to fail.

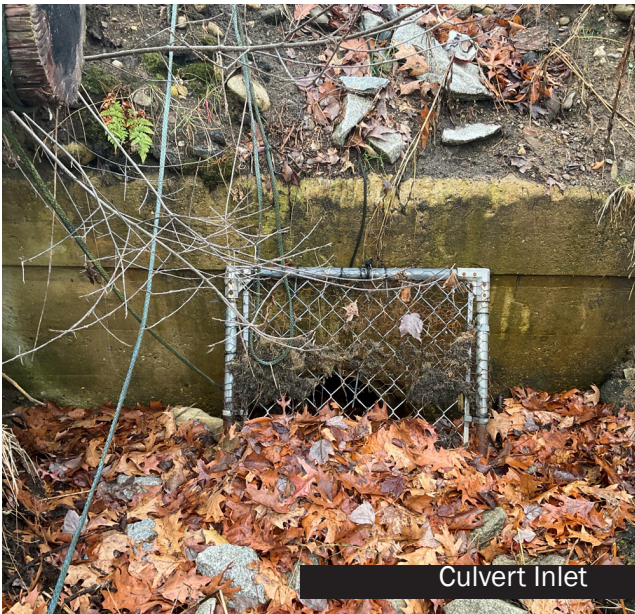
Culvert Inlet

**Existing Conditions**  
Inlet: The embankment condition was Failing with severe erosion around headwall. Minor spalling was observed at the concrete headwall with minor signs of rotation. Moderate spalling was observed at bottom of RCP pipe. The overall rating of the inlet was Failing.

**Recommendations**  
Potential repair options include replacement of the inlet headwall, re-grading and scour protection of the embankments, and sediment jetting inside the pipe.

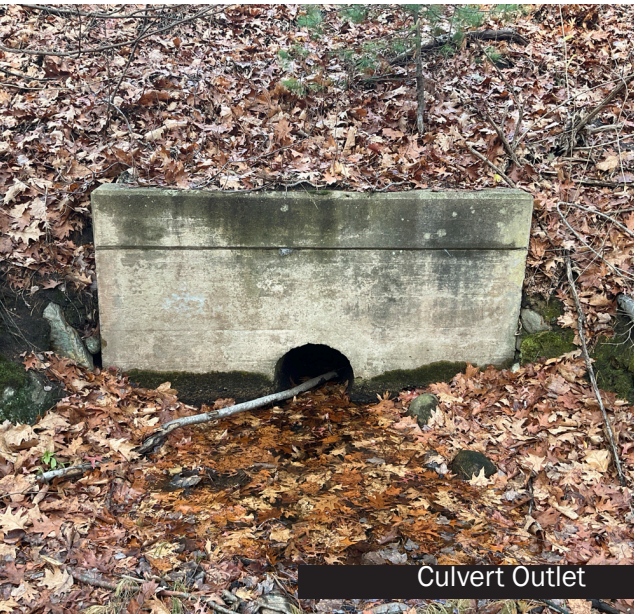
Culvert Outlet

Outlet: The embankment condition was Fair with moderate erosion on both sides of the headwall. The concrete headwall was in Fair condition with minor spalling observed at the base of the headwall. The pipe was approximately 40% obstructed with sediment and leaves at the outlet. The overall condition of the outlet was Fair.

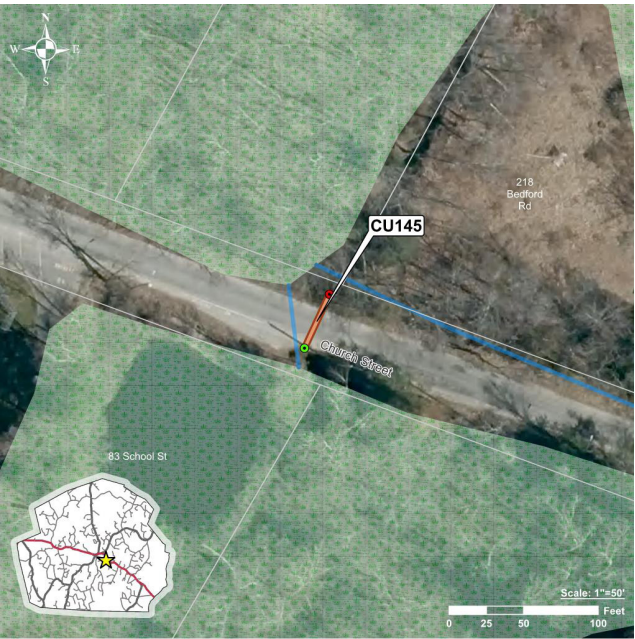
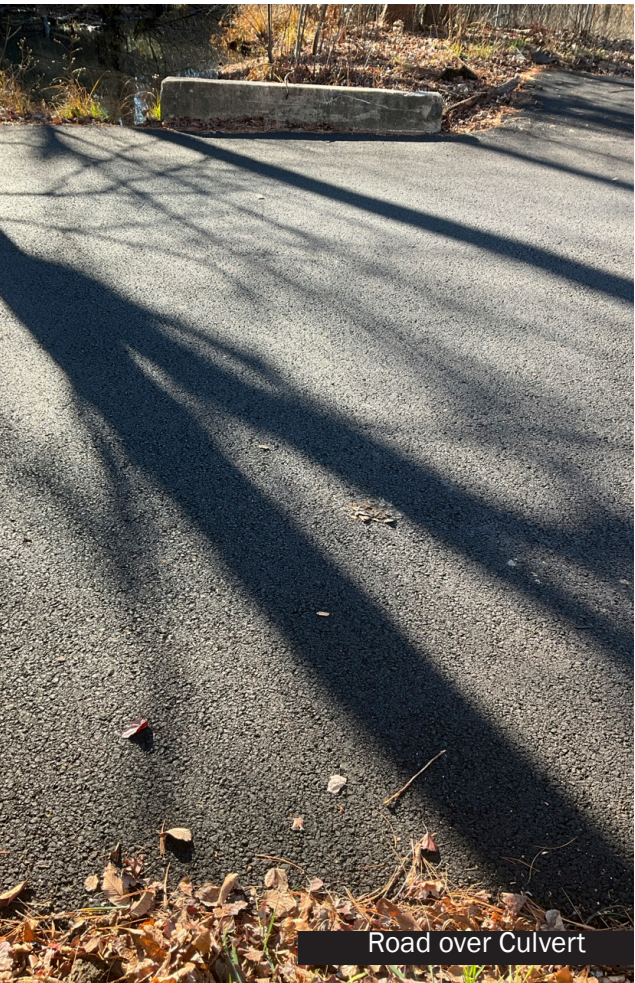
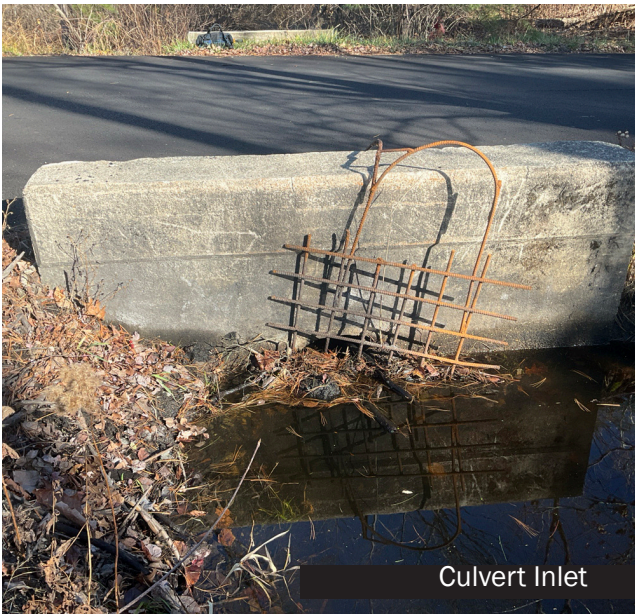
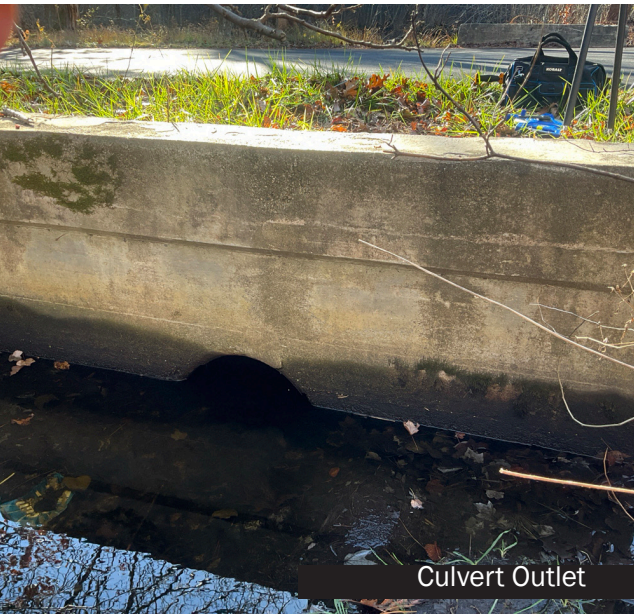
Culvert CU145 carries waterflow from a small stream under Church Street, a Minor Collector, through a 16-inch steel pipe. Church Street is a one-way road that serves Carlisle High School. The water level of the pipe was around 50% of the culvert capacity with stagnant flow. The culvert received a Poor assessment of the inlet and a Poor assessment of the outlet, resulting in a high risk of failure. Culvert CU145 is considered a Critical Culvert based on its high risk of failure and, because it is a one-way road in a school zone, moderate traffic disruption if the structure were to fail.

Inlet: The inlet has poorly vegetated embankments in Poor condition due to vegetation overgrowth and severe erosion on the right side of the headwall. The concrete headwall appeared to be in Satisfactory condition with no cracks or spalls. The pipe at the inlet had moderate rust and was obstructed with sediment and leaves.

Outlet: The outlet has poorly vegetated embankments in Fair condition due to minor vegetation overgrowth. The concrete headwall appeared to be in Satisfactory condition with no cracks or spalls. The pipe at the outlet was in Poor condition with separation between joints, significant vertical misalignment, moderate rust, but was unobstructed.

| Culvert Information | | | | | | | | | |
|---|---|---|---|---|---|---|---|---|--|
| 16 | 16 | 29 | Other - see notes | Round | None | Sediment and leaves at inlet | Poor | Steel pipe, Separation between joints, moderate rust | |

Potential repair options include re-grading the embankment, scour protection, and excavation to reset the misaligned pipe sections.

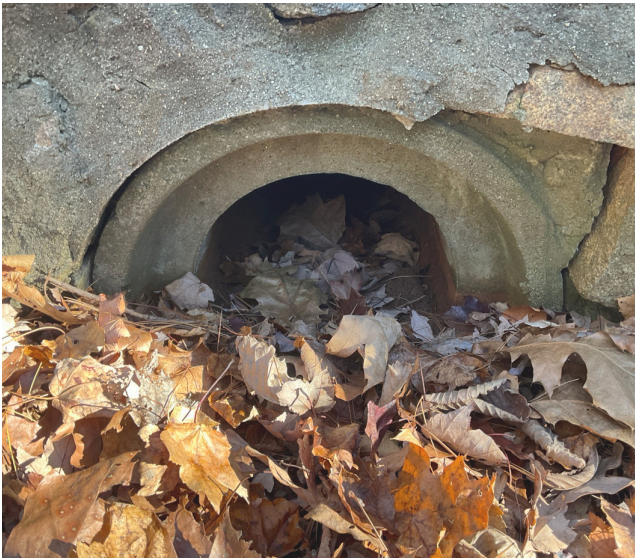
Fg 4. Culvert CU109 - Outlet 20% Obstructed

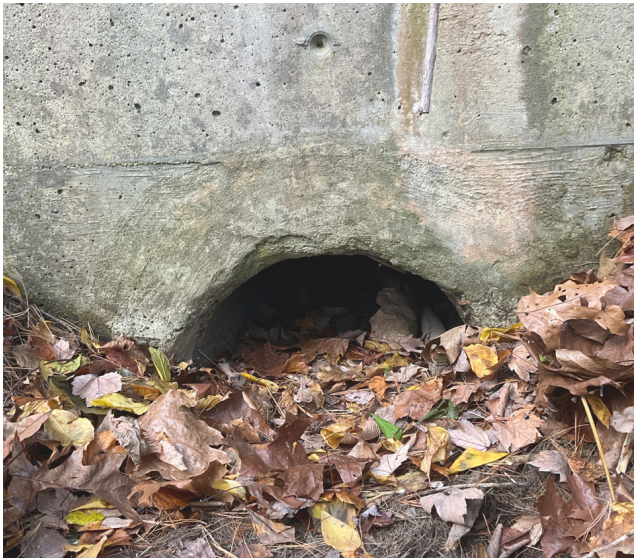
Fg 5. Culvert CU036 - Outlet 50% Obstructed

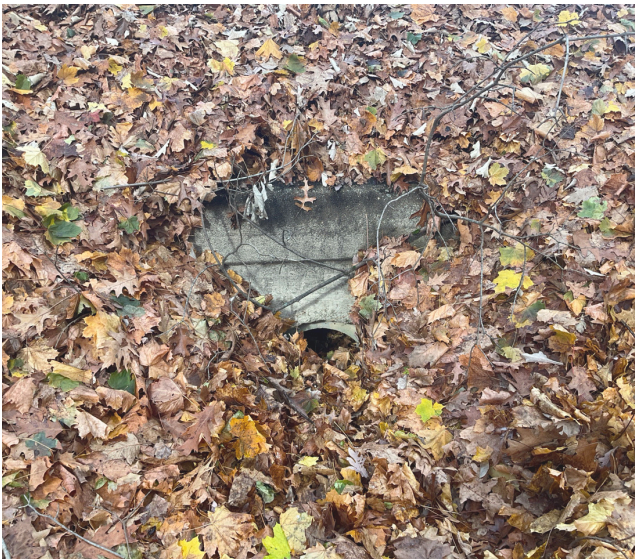
Fg 6. Culvert CU135 - Inlet 75% Obstructed

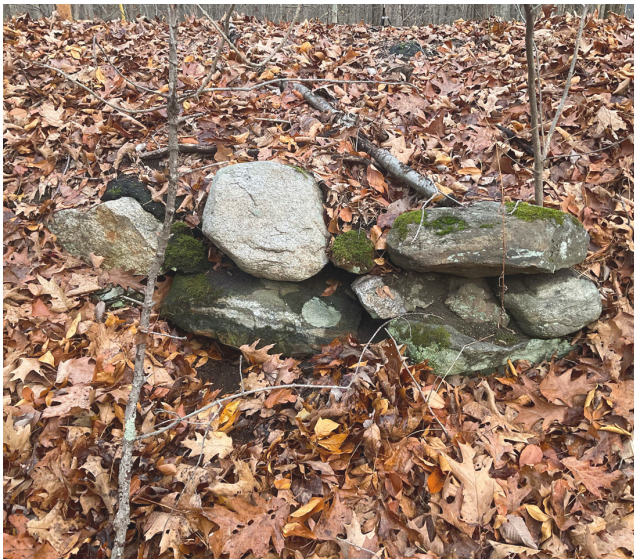
Fg 7. Culvert CU139 - Outlet Fully Obstructed

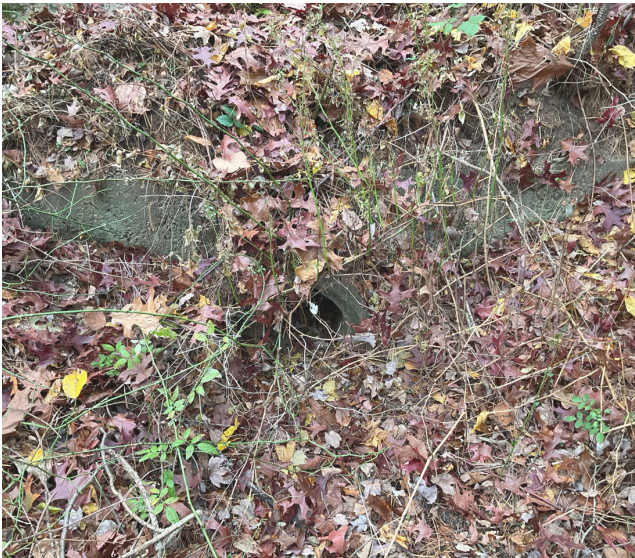
| List of Obstructions | |
|---|---|
| Culvert CU050 – Patch Meadow Ln | Obstructed with branches and leaves. Vegetation overgrowth at the inlet, no obstructions at the outlet. |

Fg 8. Culvert CU050 - Vegetation Overgrowth

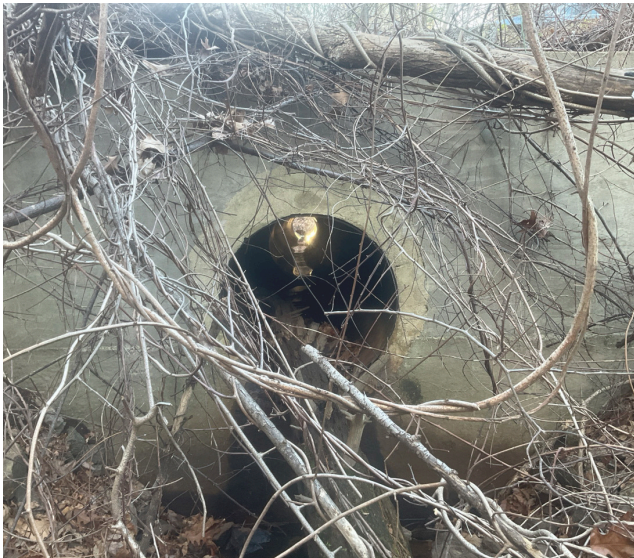
Fg 9. Culvert CU154 - Outlet Blocked by Branches

| <b>Culvert CU154 – Lowell St</b> | Fallen tree and vegetation growth obstructing outlet. |

| Culvert CU154 – Lowell St | Embankment at the outlet in Failing condition due to severe erosion of the stream banks past the outlet, severe vegetation overgrowth, and fallen trees. |
