FINAL REPORT

CRANBERRY BOG HOUSE PRESERVATION PROJECT: 2007 – 2013

A Project Funded by Carlisle's Community Preservation Act

July 2013

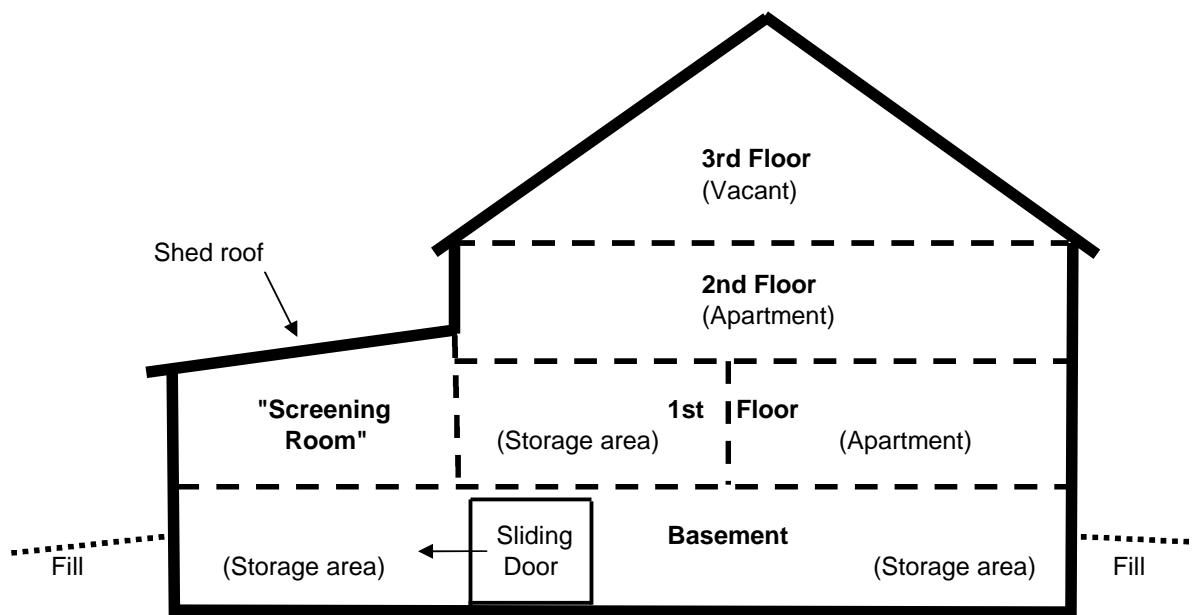
Figure 1. Schematic Diagram of Floors of Cranberry Bog House
(As viewed from east side of building)

Not to scale

Preservation work took place in the interior of all four floors of the Bog House, on both the gable and shed roofs, and on two exterior walls. In this project the four floors of the Bog House (see **Figure 1**) are referred to as the basement, first, second and third floors.
